F2605.01-113-11-R0
ACOUSTICAL PERFORMANCE TEST REPORT
ASTM E 90, ASTM E 492, ASTM E 2179

Series/Model: Luxury Vinyl Plank over 1.5 mm Fabricushion Ltd. Acoustical Underlayment

Specimen Type: Concrete Slab - 152 mm

STC	50
IIC	54
ΔIIC	25

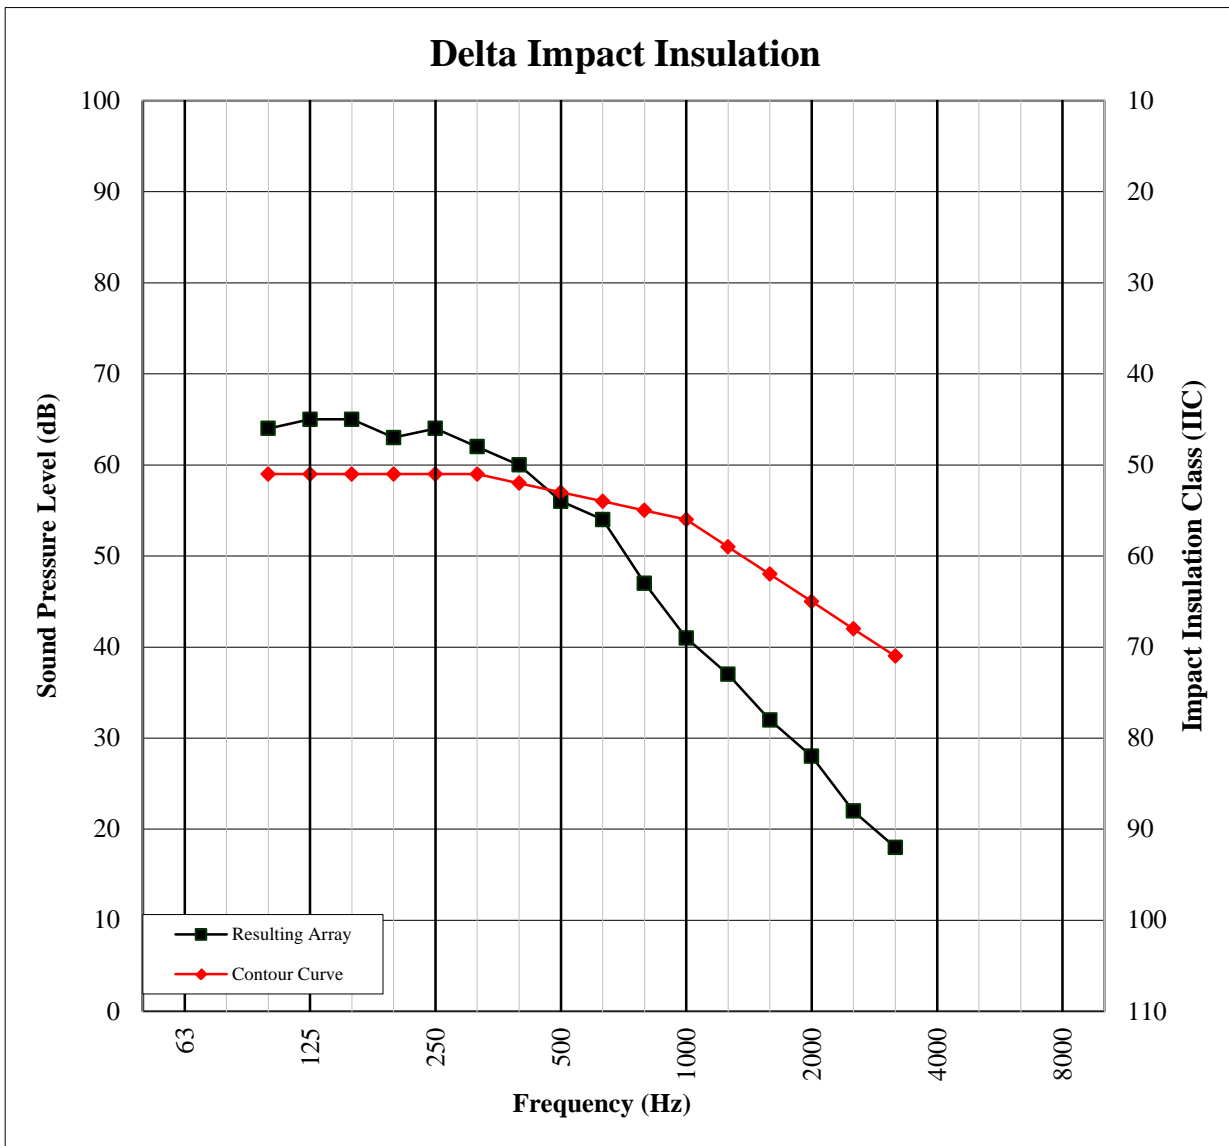
DELTA IMPACT INSULATION
ASTM E 2179

Test Date	11/05/15
Data File No.	F2605.01
Client	Fabricushion Ltd.
Description	5.07 mm CULBRES KRC356 Hillspore Oak Luxury Plank Tile, 1.5 mm Fabricushion Ltd. Acoustical Underlayment, 152 mm Concrete Slab
Specimen Area	10.98 m ²
Technician	Eric A. Thompson

Freq (Hz)	Bkgrd SPL (dB)	Absorption (Square Meters)	Normalized Impact SPL BARE (dB)	95% Conf Limit	Normalized Impact SPL SPEC (dB)	95% Conf Limit	Resulting Array L _{ref,c}	No. of Deficiencies
100	43.1	11.7	58.1	1.5	55.4	1.6	64	5
125	37.8	9.2	62.0	1.7	59.0	2.7	65	6
160	32.1	9.5	64.8	0.3	62.1	1.1	65	6
200	25.9	11.2	71.2	0.6	65.8	1.1	63	4
250	31.4	11.4	69.0	2.8	64.1	1.6	64	5
315	24.2	9.8	66.7	1.1	59.4	1.3	62	3
400	22.0	8.9	69.5	2.5	59.1	1.6	60	2
500	22.4	8.4	68.6	0.8	54.6	1.4	56	0
630	21.3	7.9	70.0	2.2	52.6	1.0	54	0
800	21.1	7.8	71.4	1.4	47.3	0.6	47	0
1000	21.4	7.9	73.0	0.8	42.5	1.4	41	0
1250	25.8	7.9	72.9	2.0	37.5	1.7	37	0
1600	17.8	8.0	74.0	3.8	34.4	1.2	32	0
2000	10.9	8.5	74.3	2.0	30.0	0.8	28	0
2500	7.8	9.1	74.1	2.4	23.9	0.3	22	0
3150	8.2	10.0	73.8	3.0	19.6	0.6	18	0

ΔIIC Rating **25** *(Delta Impact Insulation Class)*
Deficiencies **31** *(Sum of Deficiencies)*

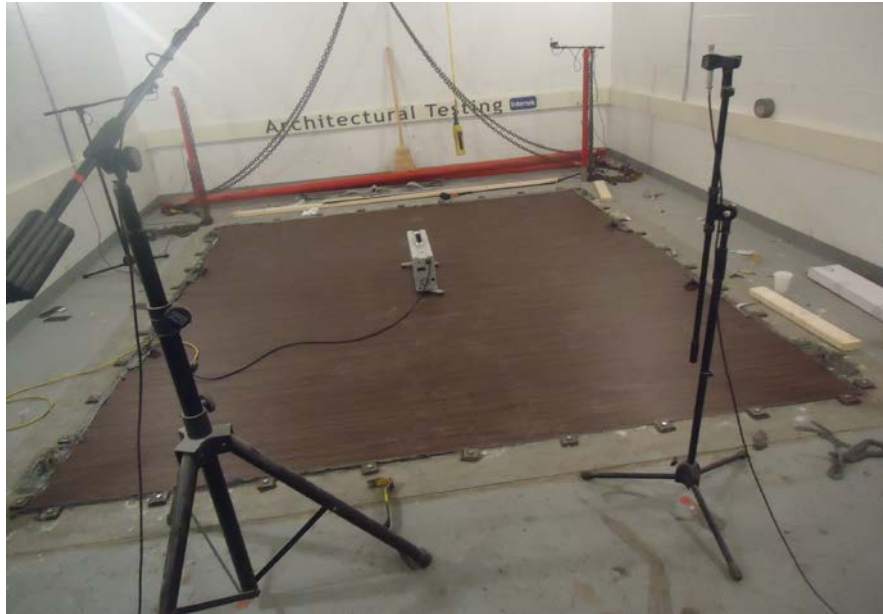
Source Room View of Test Specimen Installation

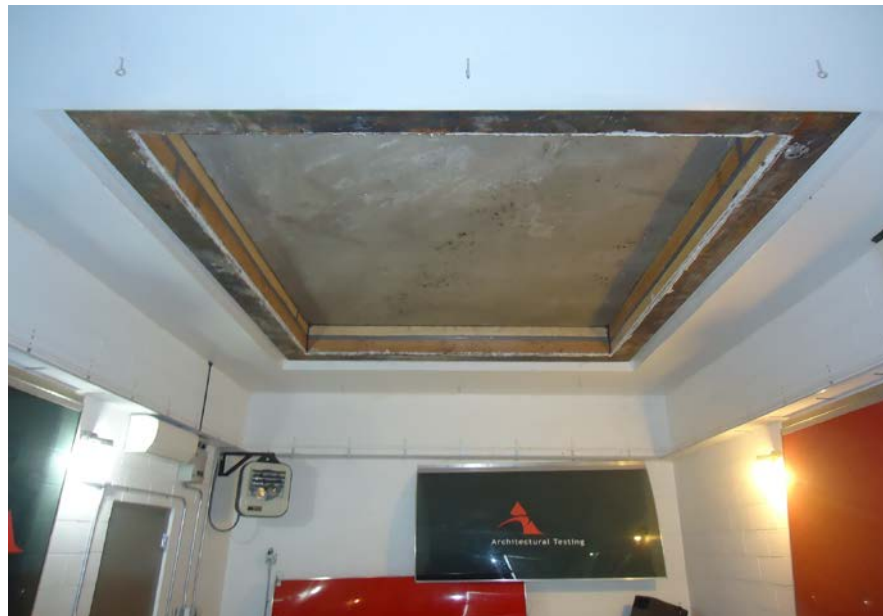
Receive Room View of Test Specimen Installation
